11th Nordic Symposium on Building Physics, NSB2017, 11-14 June 2017, Trondheim, Norway

# Moisture damage with magnesium oxide boards in Danish facade structures

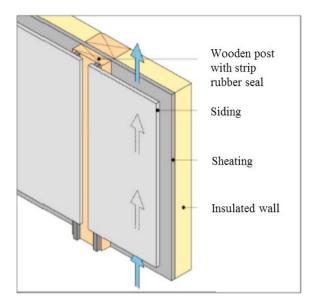
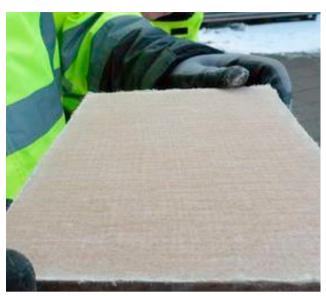
Fig. 1. (a) Sketch of a typical façade construction where a sheathing board is used as wind barrier. Adapted from [1]; (b) Photo of 8 mm thick MgO-board with a glass fibre mesh on both surfaces.

Fig. 2. (a) The MgO-board is placed facing the air gap, which is behind the siding boards made of natural slates; (b) Salty water drops on a vertical MgO-board on the side that faces the insulation filled cavity inside the wall.

Many moisture damages were observed in winter 2014/15 in ventilated facades of new or newly renovated Danish buildings. The damaged facades had magnesium oxide-boards (MgO-boards) as sheathing facing the ventilated air gap behind the exterior siding. MgO-boards have often been used as sheathing behind a ventilated air gap as shown in Figure 1a and Figure 2a. A photo of an MgO-board is shown in Figure 1b. Examples of saltwater leaks and subsequent damage are shown in Figure 2b, 3a and 3b.

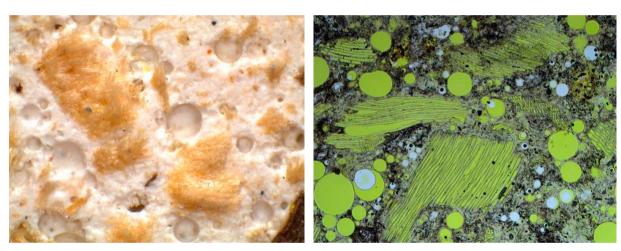
Fig. 4. (a) Cut of a MgO-board investigated in a stereo microscope at 10 times magnification; (b) Micro analysis of a thin section of a specimen at 50 times magnification.

The binder in MgO-boards is formed by a chemical reaction between MgO and MgCl<sub>2</sub>, typically in a weight ratio of 2.5-3.5 parts MgO to one part MgCl<sub>2</sub>. The product is quite similar to Sorel cement, which was first produced by Stanislas Sorel in 1867 [2] and used as a flooring material. Various explanations about the product and its possible use and qualities can be found in literature [3-10]. The hydrated product is hard and strong but the product decomposes over time by contact with water or air at high relative humidity (RH). MgO-boards often have organic additions, such as sawdust, and inorganic fillers such as sand, lime or volcanic ash. Figure 4a shows a picture of an MgO-board from a stereo microscope at 10 times magnification. Figure 4b shows a microanalysis of a thin section of a specimen at 50 times magnification that reveals that the investigated MgO-board contains a high amount of very porous organic material, and a high number of fine spherical air pores. All investigated MgO-boards have glass fibre felt as facer.

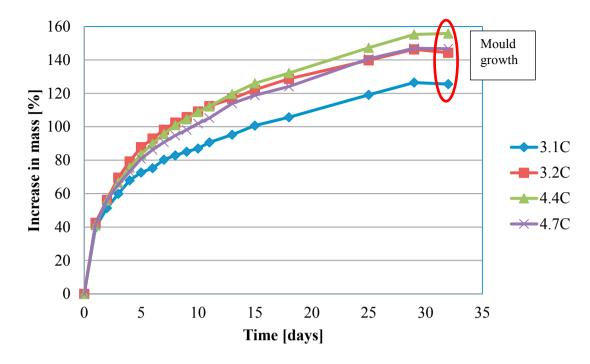
Moisture absorption in MgO-boards from the surrounding air was measured at three different levels of relative humidity at 23 °C: 35% RH, 80% RH and 95% RH. Before start of the moisture exposure, samples of size 5 x 4 x 3 mm were dried at 105 °C for 4 days. MgO-samples with a total weight of about 2 g were put in a petri dish, which was placed in a Teflon basket, and weighed without removal from the climate chambers. The specimens were weighed after 0, 1, 2, 3, 4, 5, 7 days and after 2 and 4 weeks. Specimens exposed to 35 % RH reached 6-7 % moisture content by weight after a week and then remained at that level, while specimens exposed to 80 % RH reached 26 % by weight after a week, and about 30 % after 4 weeks (48 % for one of the specimens). Results are presented in Figure 5 for specimens exposed to 95 % RH. Mould growth was seen after 30 days of exposure to 95% RH.

Fig. 5: Course of the moisture retention at 95% RH.

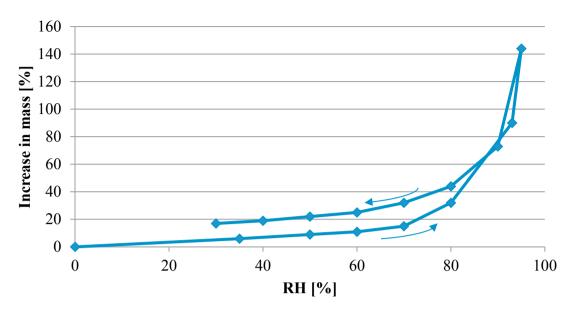
Absorption was measured for specimens that were originally used for initial moisture absorption at 35% RH. The absorption points were measured from 35% RH and up to 92% RH. An example of the results of the absorption and desorption measurements is shown in Figure 6.

Fig. 6: Results of the absorption and desorption measurements for one of the specimens.

Subsequent measurements of absorption and desorption were performed for the same four specimens that were analysed for initial moisture absorption at 35% RH and 80% RH, i.e. the initial dry masses were known. Desorption was measured for the specimens that were originally used for determination of initial moisture absorption at 80% RH. Before starting the desorption runs, the humidity of the climate chamber was increased from 80% RH to 92% RH in steps of 2% RH with the purpose of finding the level of RH at which the specimens began to leak salty water from the surface (sweating). The first part of the tests (at 95% RH) had revealed that specimens show severe sweating after one week, while boards at 80% RH apparently did not sweat after 80 days of exposure. In view of the risk of mould growth at RH higher than 92% RH, desorption was started at this RH.

After equilibrium had been attained at 30% RH, drying of two of the specimens was performed at  $105\,^{0}$ C, while the two other specimens were dried over magnesium perchlorate at room temperature. The purpose of the repeated drying by the end of the sorption tests was to see if the dry masses were the same as before the measurements. The results were that one sample had lost 0.3% in dry weight, while the other three specimens saw dry weight losses of  $12-15\,\%$
