School of Science and Engineering

STUDY OF THE DEGRADATION OF
MAGNESIUM OXIDE WALLBOARD

BACHELOR OF ENGINEERING (MECHANICAL) (HONOURS)

SUBMITTED: OCTOBER 2017

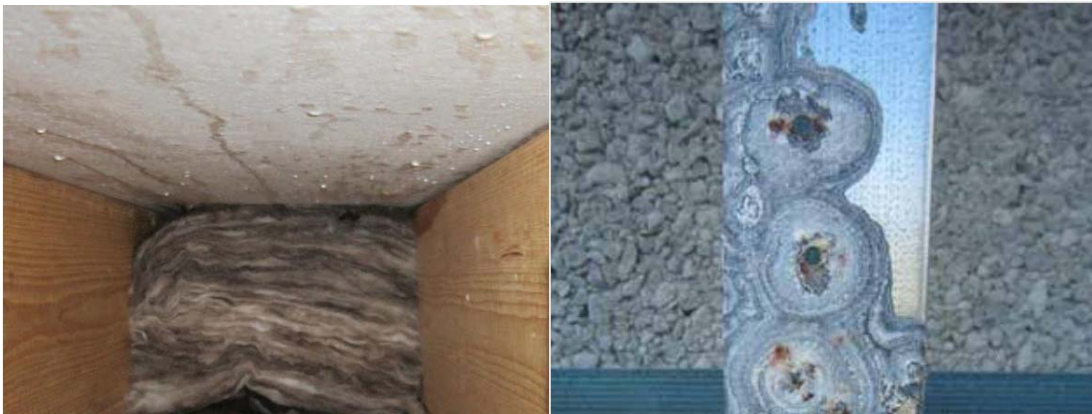
Figure 2-1-Evidence of damages due to MgO boards: Leachate visible on MgO board due to excessive moisture absorption (left) and corrosion of contacting metal framework (right)
Source: (Hansen et al. 2016)

Studies conducted on the Danish MgO board problem had implicated the tendency of the MgO sheets to absorb moisture from the environment, leading to leaching of saline water. A detailed study by Bunch Bygningfysik (2015) found that after 7 days exposure at 90% relative humidity, leaching was observed. A report conducted by the Building Damage Fund Denmark concluded that the MgO panels used were not suitable for use as a wind breaker in Danish conditions as the relative humidity throughout winter often peaked above 90% RH and thus can lead to leaching to the saline solution which is attributed to the dampness and resulting corrosion of metal fixtures (Byggeskadefonden 2015). This saline solution resulted in the corrosion of non-stainless steel fixtures. Bunch Bygningfysik (2015) further found that the MgO sheets can lose cohesion over time as the binder decomposes at relative humidity's above 95%. These results related to the use of MgO board branded as "Eco Board".

Hansen et al. (2016) concluded that relative humidity's above 84% would result in excessive moisture absorption, resulting in leaching. This leachate contained corrosive elements, such as Cl^- and Na^+ , which then lead to corrosion of metallic fixtures around the boards.

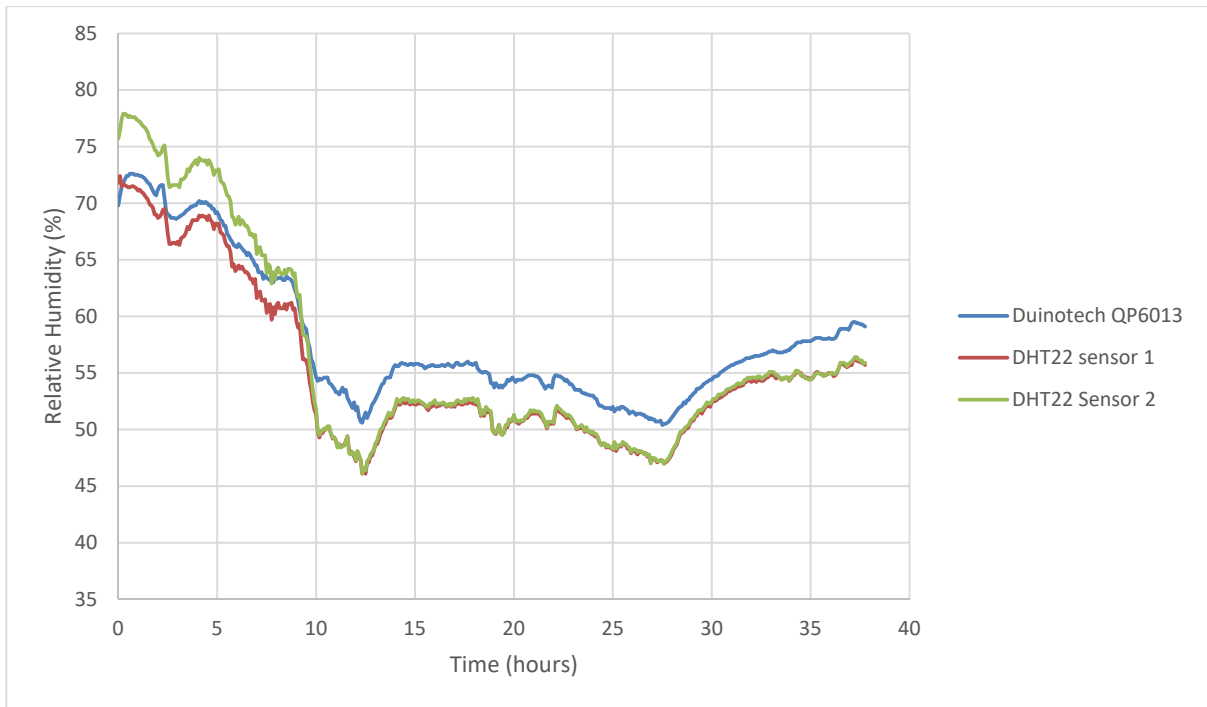
Figure 3-3-Validation of DHT22 sensors

A comparison of the DHT22 sensors and the Dainotech QP6013 is shown in Figure 3-3. The sensors monitored ambient conditions over 36 hours in order to compare the performance of the DHT22 to the well-established Dainotech Qp6013. It is shown that RH values follow similar trends over the 36-hour period. However, there is a near constant difference of approximately of 3-5% RH. This was deemed an acceptable tolerance as the environmental chamber humidity was controlled with saturated salts with known relative humidity values.

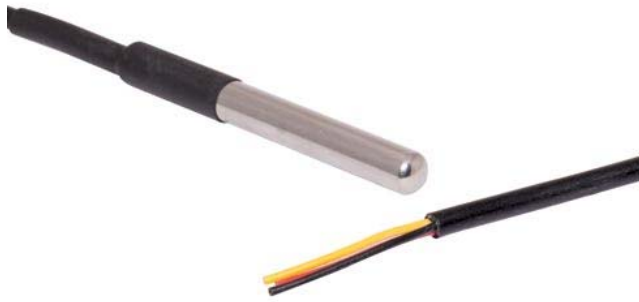
Figure 3-4-Stainless steel housing waterproof DS18B20 temperature probe

For validation of the water absorptivity analysis, the water temperature was monitored. This task required a waterproof temperature sensor that was capable of recording the water temperature at intervals. As both the humidity datalogger (high humidity moisture absorption analysis) and the water temperature datalogger (water absorptivity analysis) were not required simultaneously, the humidity datalogger was repurposed to operate as a water temperature datalogger. The DHT22 humidity sensors were replaced with a Waterproof DS18B20 Temperature Probe (Figure 3-4) in the schematic shown in Figure 3-2, and the code rewritten to incorporate the sensor (Appendix 7).

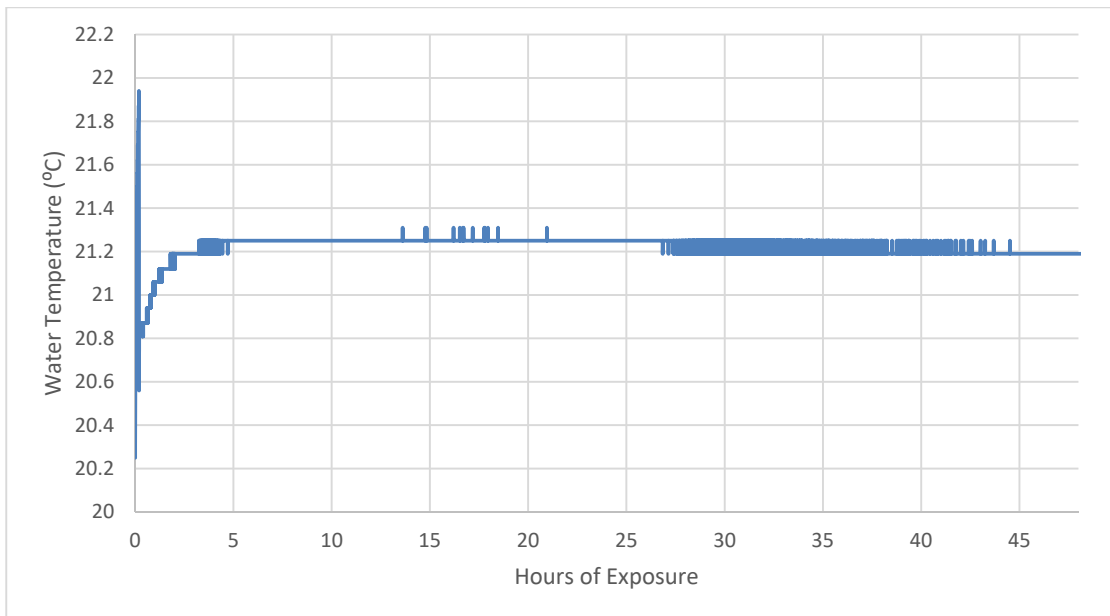
Figure 3-6- Water immersion temperature validation

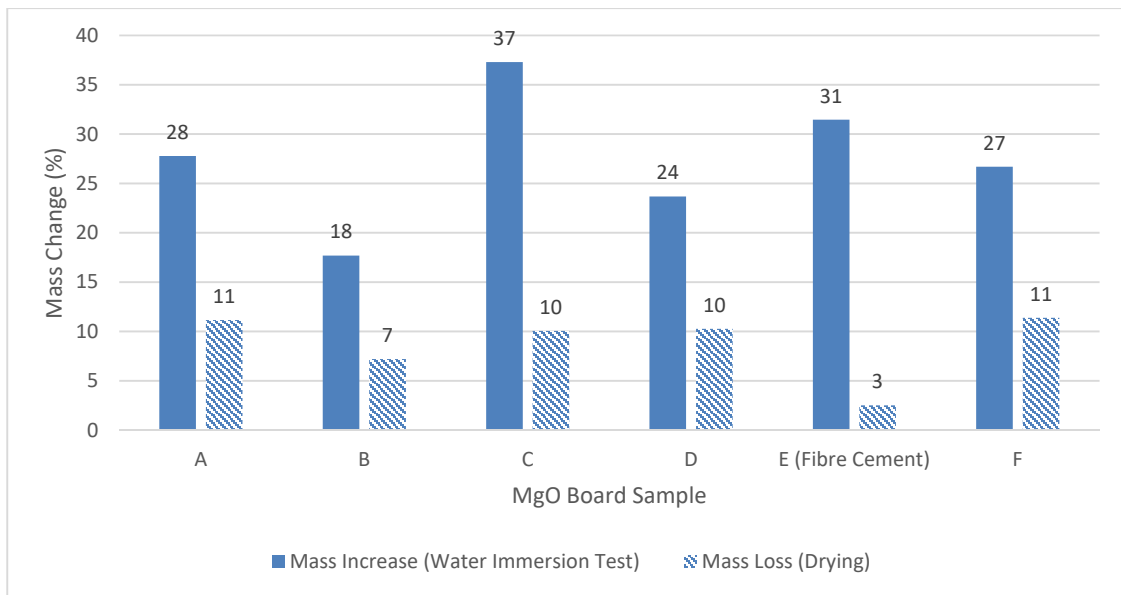
Figure 4-1- Comparison of mass change due to 48-hour water immersion

Sample B had the smallest mass decrease from the “as received” state compared to other MgO boards during the drying process, and gained the least through water submersion. This suggests sample B has a lower tendency than the other MgO boards to absorb water. Sample C absorbed significantly more water than other MgO boards, and is the only MgO sample to have a higher mass increase than the cement fibre board (sample E).

Fibre cement samples lost significantly less mass during the drying process, suggesting they absorb less moisture in ambient conditions (as supplied) than magnesium oxide samples. When submersed in water however, the control samples had a larger mass increase than most MgO samples. This is attributed to the large concentration of wood fibres often used in fibre cement boards.

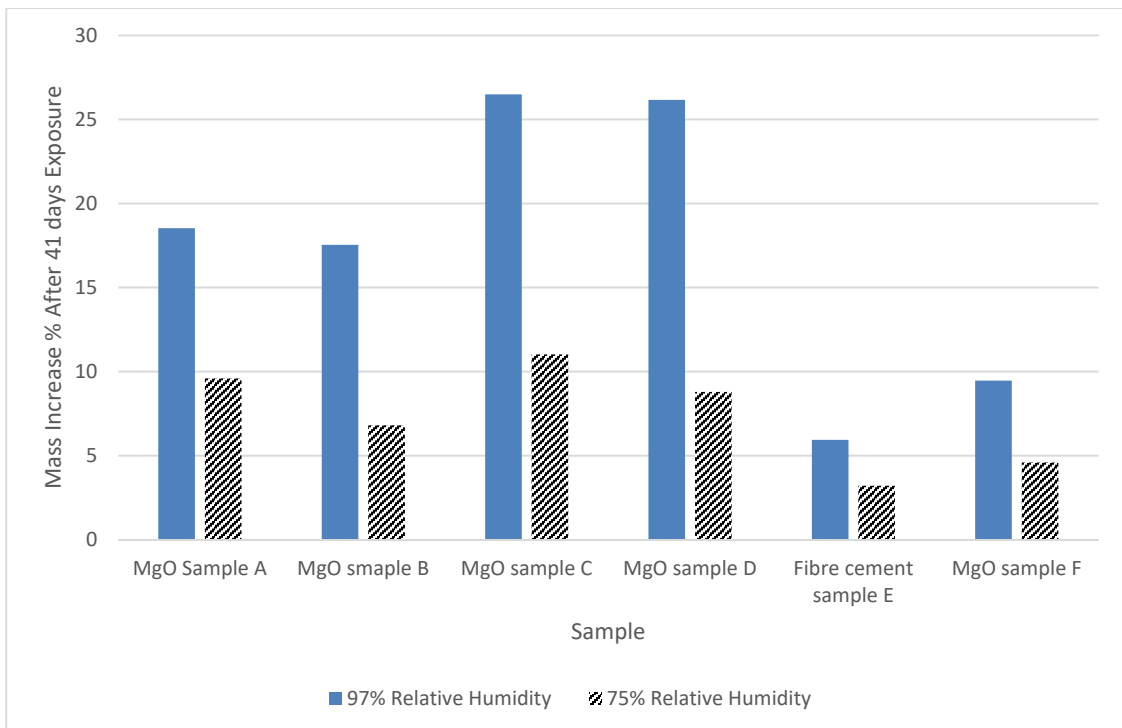
Figure 4-5- Effects of relative humidity on moisture absorption

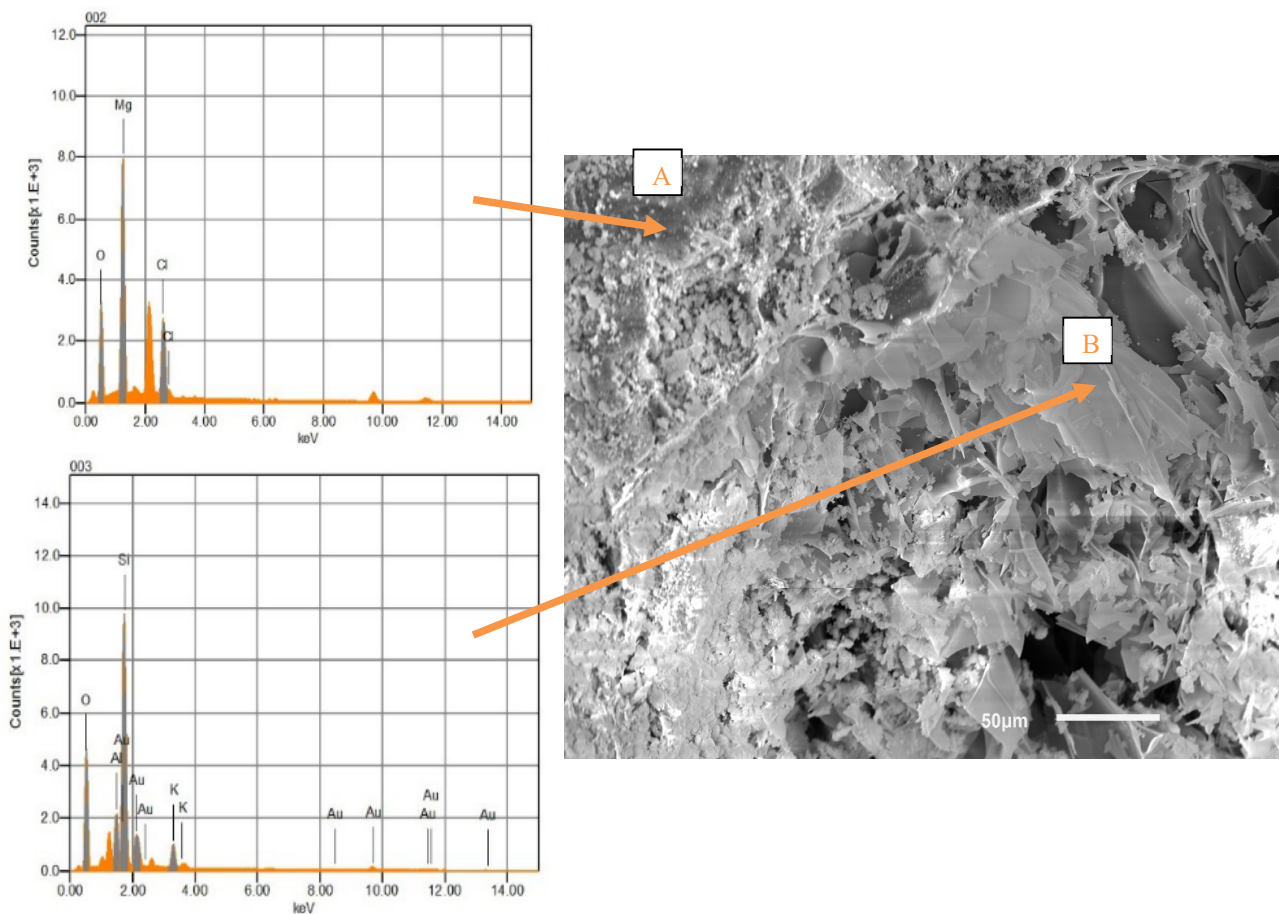
Figure 4-8- EDS analysis of sample B, showing the presence of perlite (point B) within the MgO structure (point A)

Many of the porous sections observed in MgO samples can be attributed to perlite used as a filler in the material composition, which is introduced to increase the fire resistance of the boards. This is supported by Table 4-3, which shows the composition of perlite, which when compared to the SEM/EDS analysis of the samples shown in Figure 4-8, demonstrates the presence of perlite.

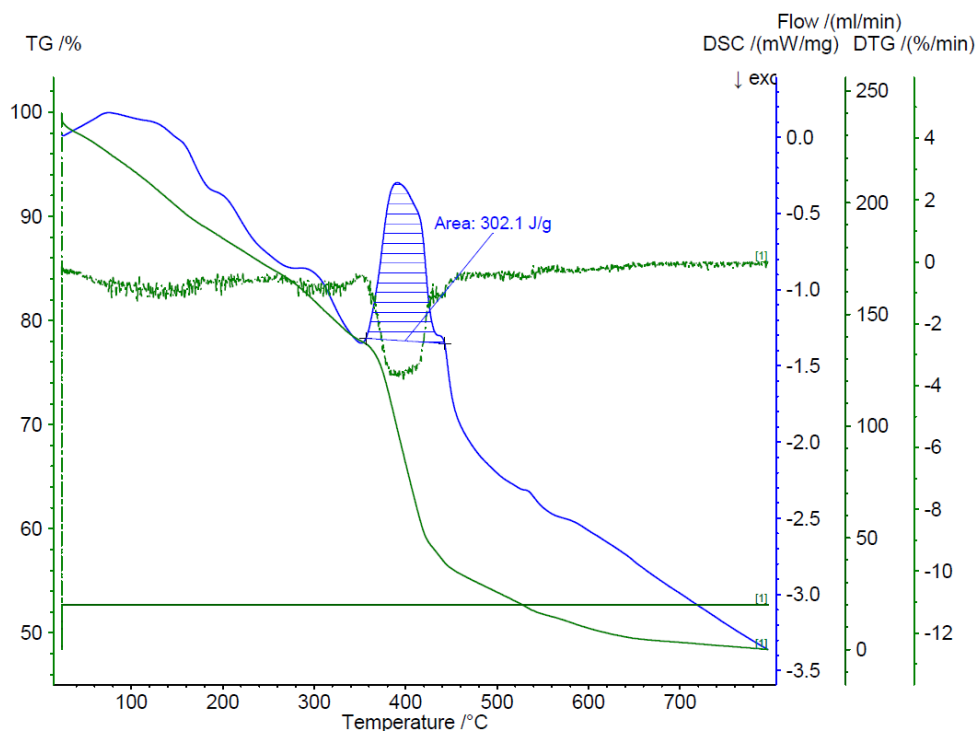
Figure 4-11- Thermal analysis showing DSC for MgO sample B

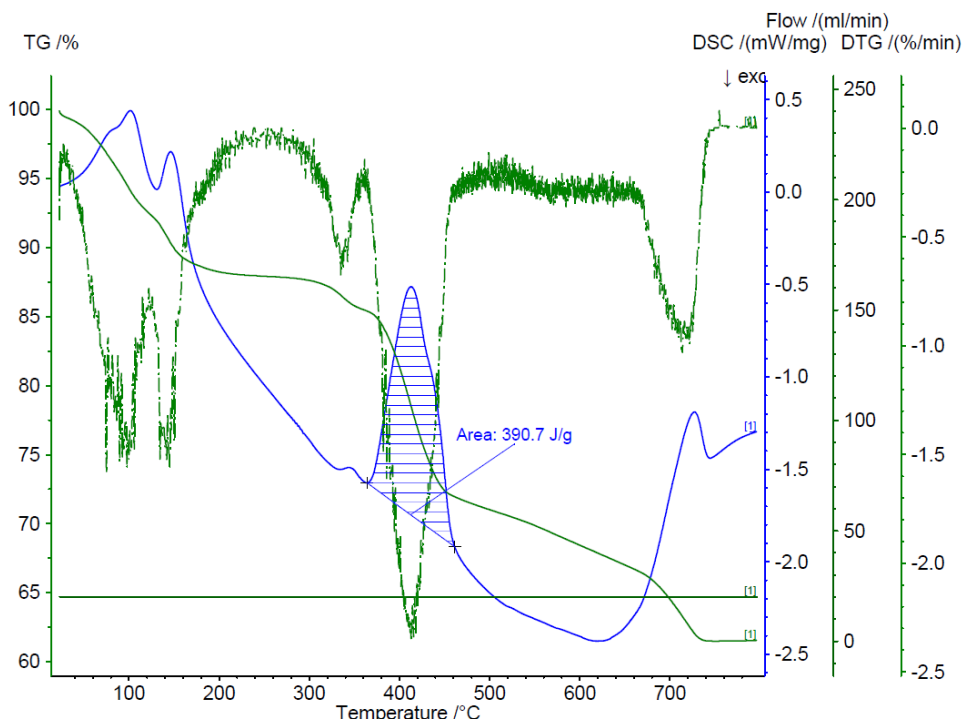
Figure 4-12- Thermal analysis showing DSC for MgO sample F

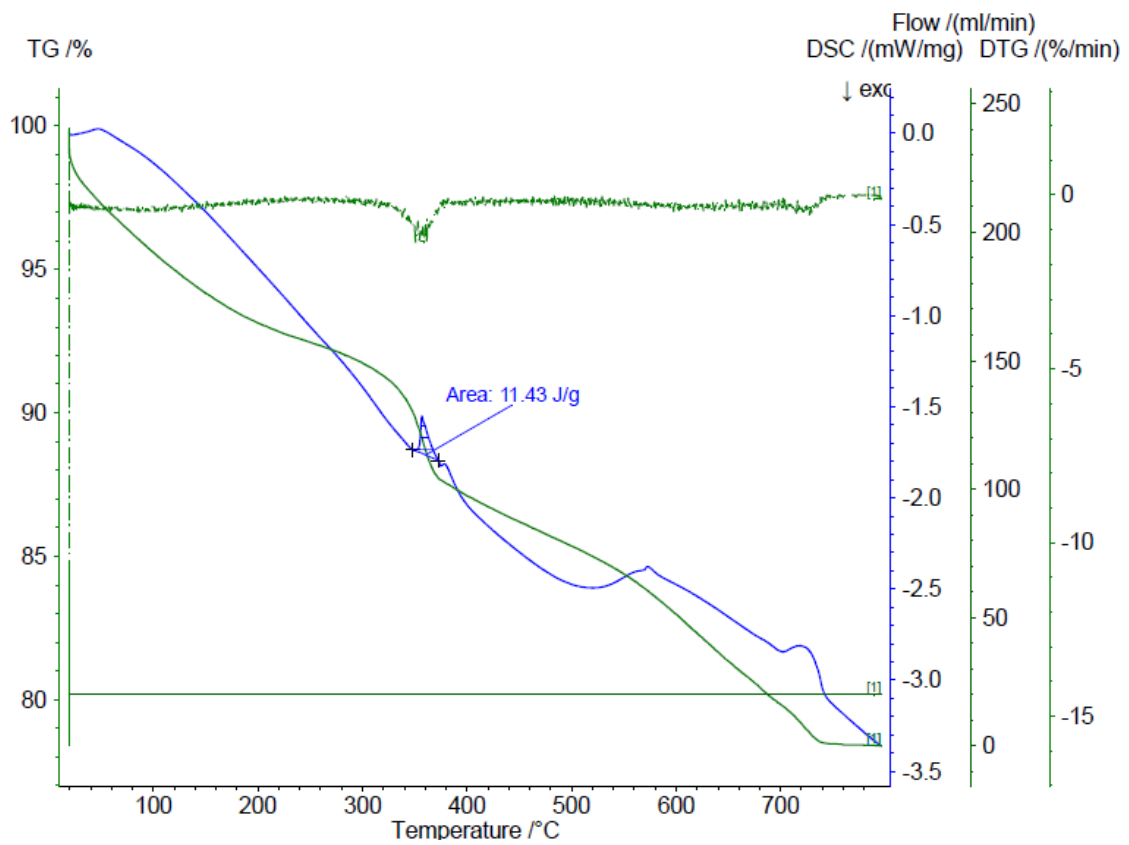
Figure 4-13- Thermal analysis showing DSC for fibre cement sample E

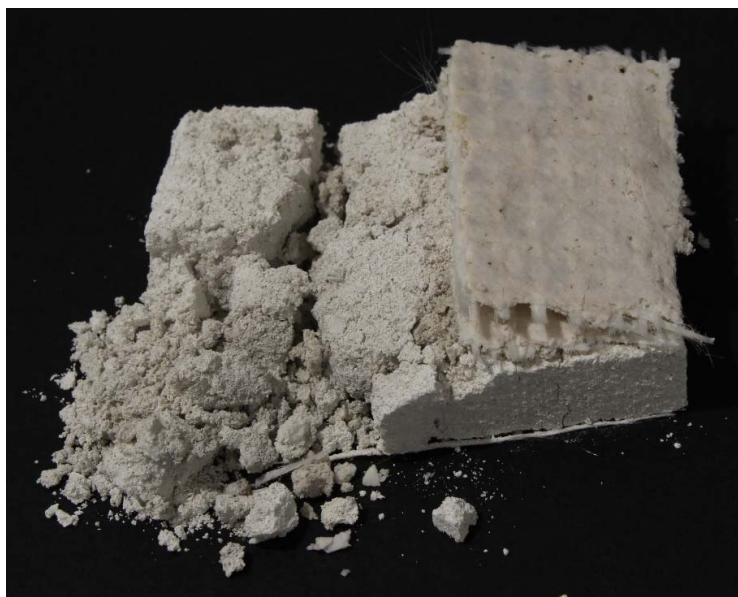
Figure 4-14- MgO sample C after 24 hours at 500°C

In order to verify that DSC and TG thermal event is due to structural water release, a sample of MgO board was heated in an oven at 500°C for 24 hours. Figure 4-14 shows the picture of sample C after such thermal treatment. The crumbling evidenced after the heat treatment is attributed to the loss of structural water, a key mechanism of the cementation process for rigidity of cement solids.

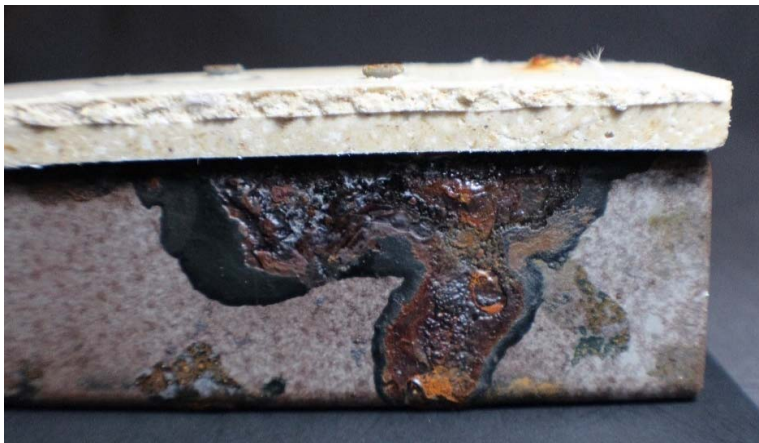
Figure 4-20-Corrosion of steel section due to leachate

The effects of leachate on steel section can be shown in Figure 4-20. MgO sample B excreted leachate during testing, which flowed down onto the contacting steel section. Due to the presence of chloride in the leachate, severe corrosion of the steel section occurred.

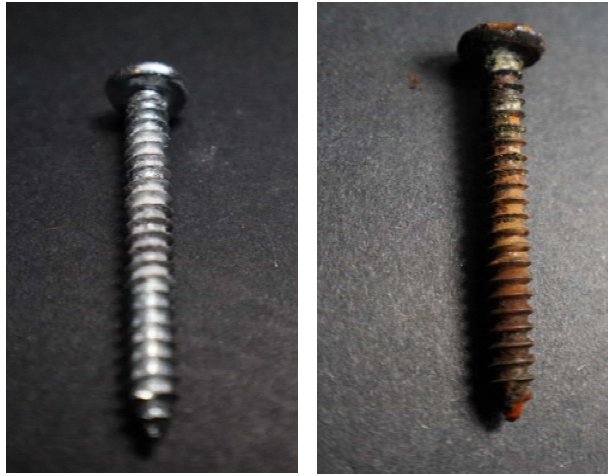
Figure 4-21- Comparison of corrosion of zinc coated fasteners in MgO board F (steel) (left) and MgO board B (steel) (right)

Although stainless steel fasteners resisted corrosion when used in conjunction with all MgO boards analysed, the use of other fastener types may be suitable for less corrosive boards. A comparison of the zinc coated fastener in MgO sample B and MgO sample F is shown in Figure 4-21, where severe corrosion is evident on the fastener contacting MgO sample B, however no corrosion was evident on the fastener contacting MgO sample F. This is demonstrated in the SEM/EDS analysis shown in Figure 4-22, which shows no chloride was detected on the sample fastened to MgO sample F, and high concentrations of chloride were detected on the fastener in MgO sample C. The large concentrations of zinc evident on the surface of the MgO sample

F fastener suggest the zinc coating is largely intact, however the large concentrations of iron detected on the surface of the MgO sample B fastener suggest the zinc coating is largely removed, a consequence of corrosion.
